# **Hunter River Trees *Pty Ltd***

**The Manager,  
Anambah Constructions,  
Re 106 New Highway,  
Rutherford, NSW, 2320.**

**Ref No: 0018a/2017.**

**Date: 01<sup>st</sup> August 2017.**

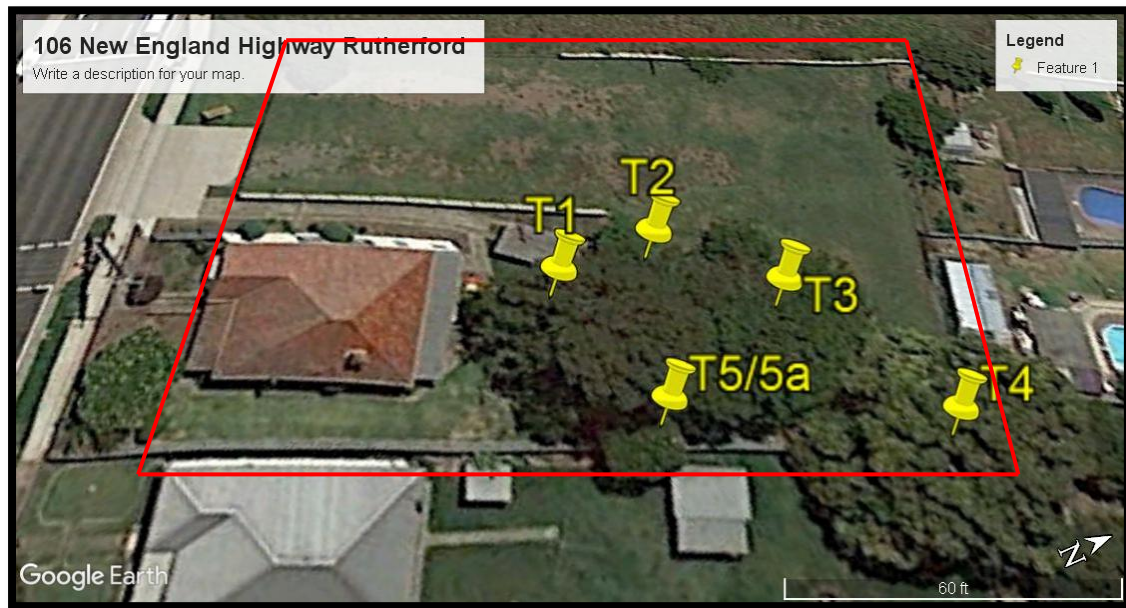
Figure 1 Google Earth image of site with area covered by report outlined in red and the trees mentioned in report numbered Tree 1 to 5/5a (Google Earth 2016).
